## North of 60

# Report on Municipal Services in Communities of the Northwest Territories NSRG 73-1

By G. W. Heinke

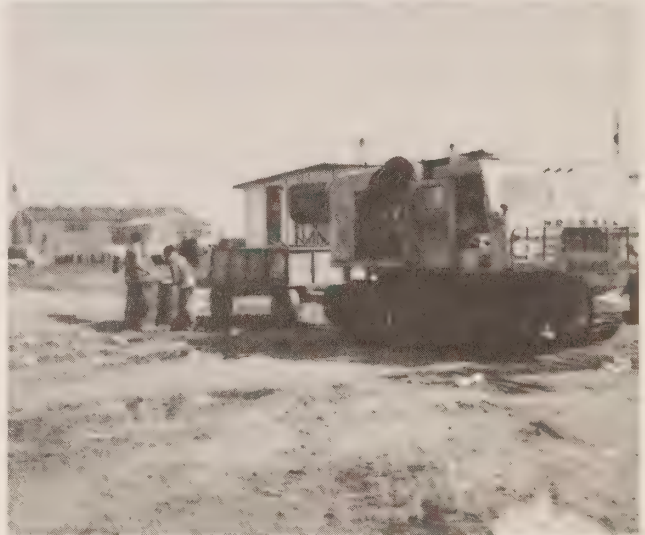
Garbage and honey bags are collected in a 6 foot by 8 foot by 3 foot high cart pulled by the Nodwell. At each home, all three men help to lift drums containing dry garbage onto the cart for dumping (Photo EP-7). Honey bags are removed by hand. (Photo EP-8) and thrown onto the truck. During the handling operation, many break, dripping their contents through leaks in the cart onto the ground in the settlement. Liquid in the cans is dumped into the cart, from which it, too, leaks out.

PHOTO EP-7—Garbage Pickup.

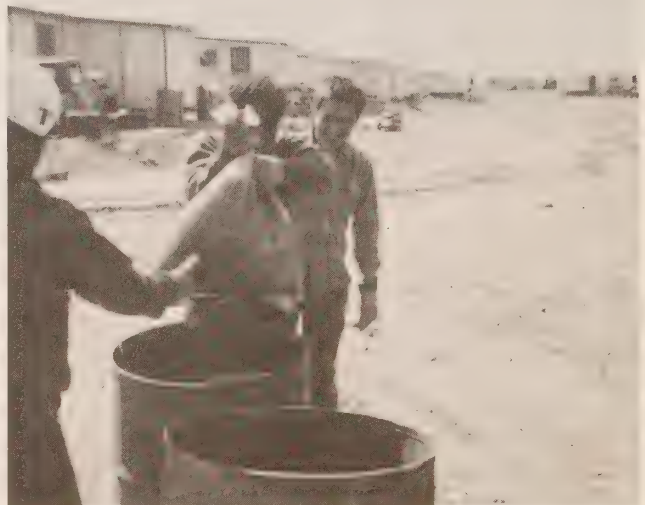
PHOTO EP-8—Manual handling of honey-bags.

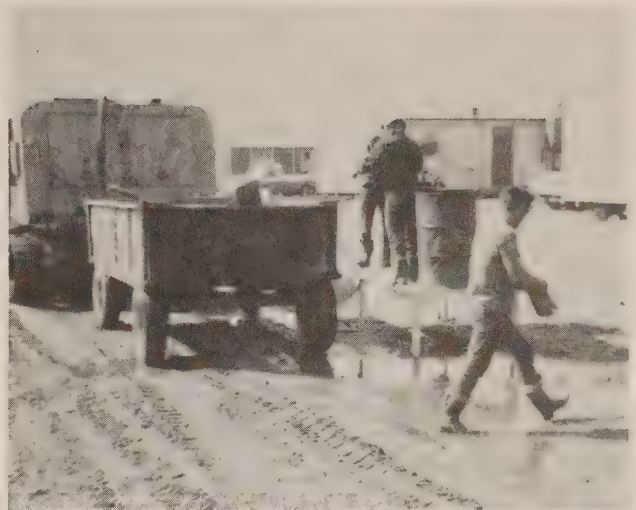
Most cans are placed on the ground, but some residences have wooden stands about the height of the cart (Photo EP-9). The collectors mount the stands and dump the cans into the cart. In the operation, the stands become coated with liquid from the drums.

PHOTO EP-9— Garbage cart and stand.

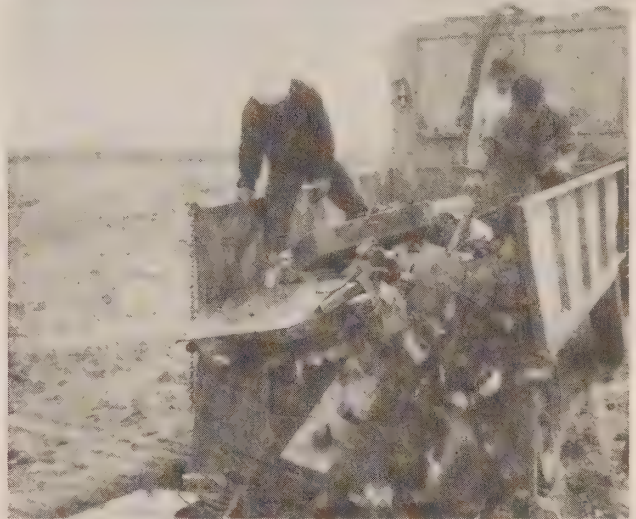
PHOTO EP-10— Garbage being shovelled and kicked from cart.

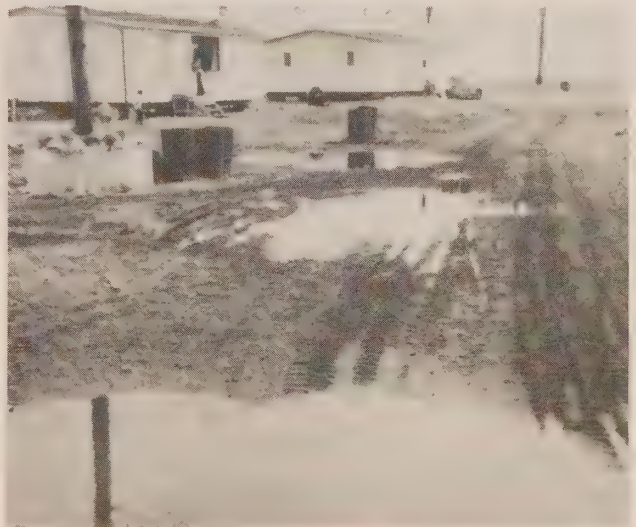
PHOTO EP-11 — Road in Eskimo Point. Note puddles.

The road material is earth, gravel, and stone. After a heavy rain, the settlement becomes a quagmire. Gravel road improvements is hauled from a borrow pit near the dump.

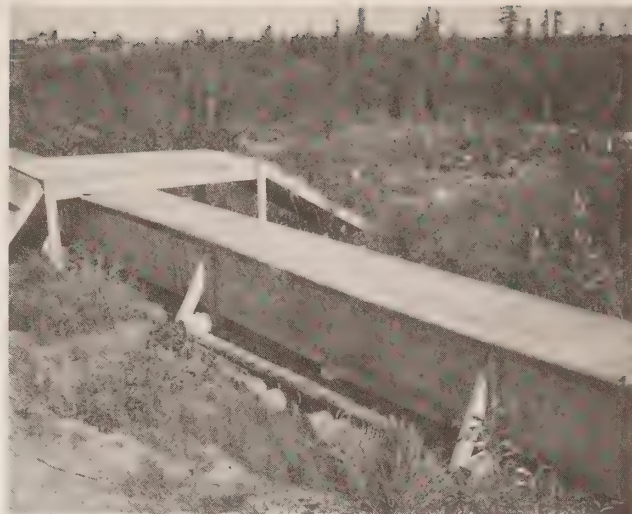
PHOTO FM-4 – Use of logs to level utilidor.

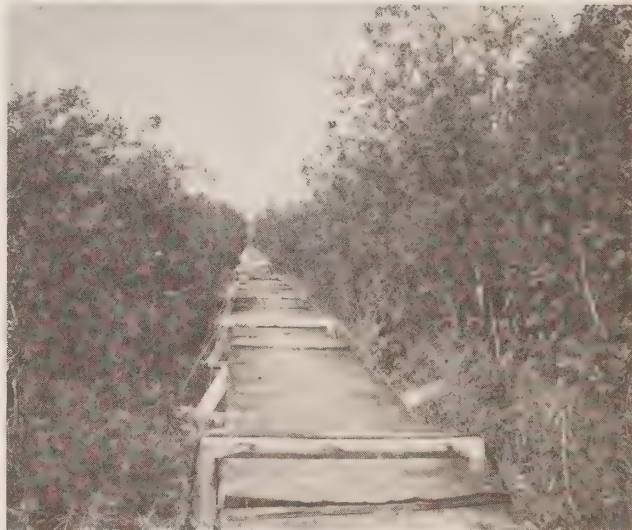
PHOTO FM-5 – Sewage outfall utilidor—note twisting.

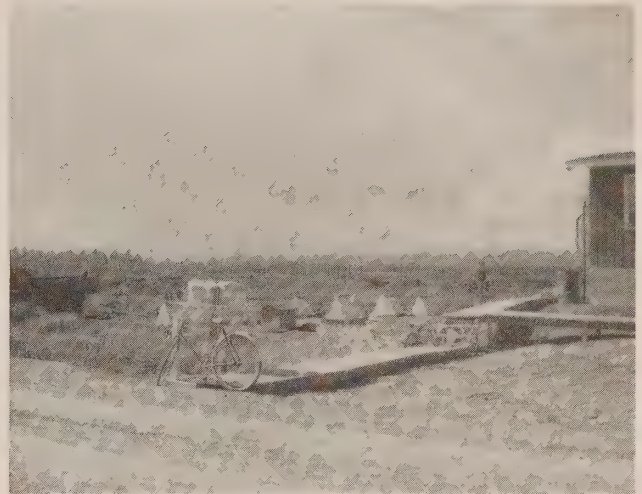
PHOTO FM-7 – Garbage barrels on rack.

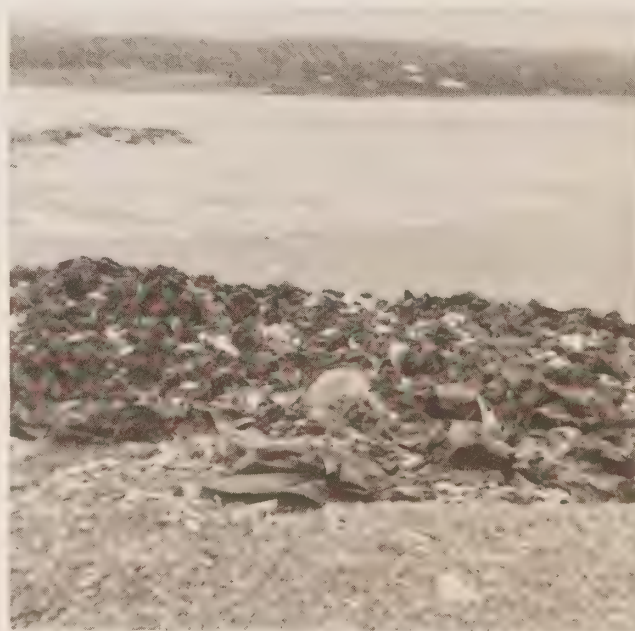
PHOTO FB-4—Honey bags on west shore of bay.

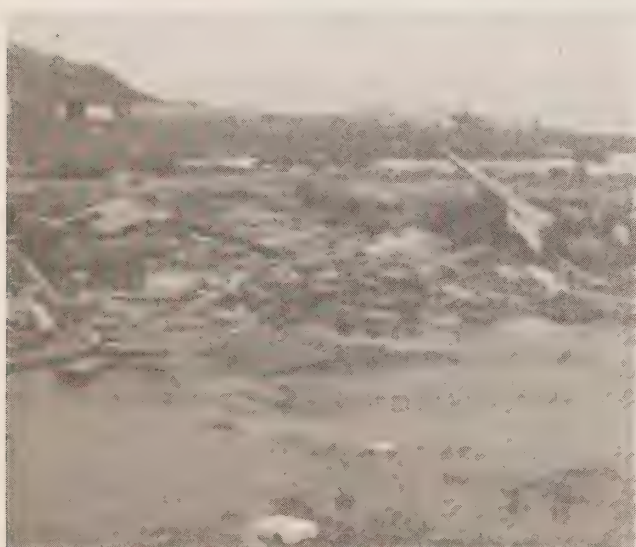
PHOTO FB-9— Garbage on shore—Ikaluit.

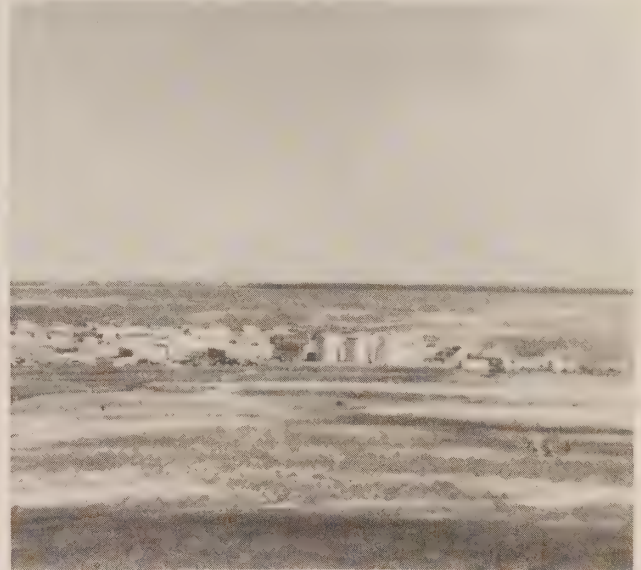
PHOTO IG-1 – Settlement of Igloodik N.W.T.

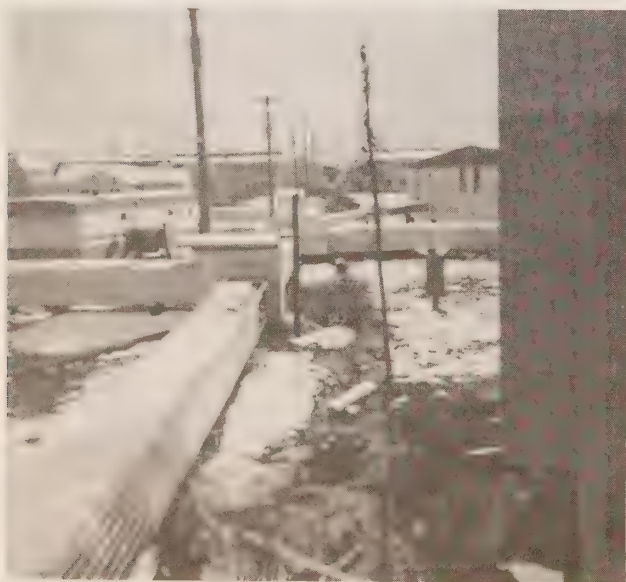
PHOTO IN-2 - The original utilidor lifted by frost action. The pile in the foreground has remained stable while the adjacent piles heaved. The gap is 2" wide. Standing pools of water (to the left in the photograph) may have contributed to the problem of pile heaving.

Many private lots are at least partially covered with water and garbage year round. Runoff underneath Sir Alexander Mackenzie School and the alongside parts of the utilidor is at least partially the cause of heaving of the piles.

- Surface drainage water should be diverted from the utilidor right-of-way in order to prevent deterioration of the foundation.
    - Pile supported utilidor lines on side hills and running parallel to the contours are subject to lateral displacement, while utilidor lines running at right angles to a slope would have more rigidity to withstand soil movement.

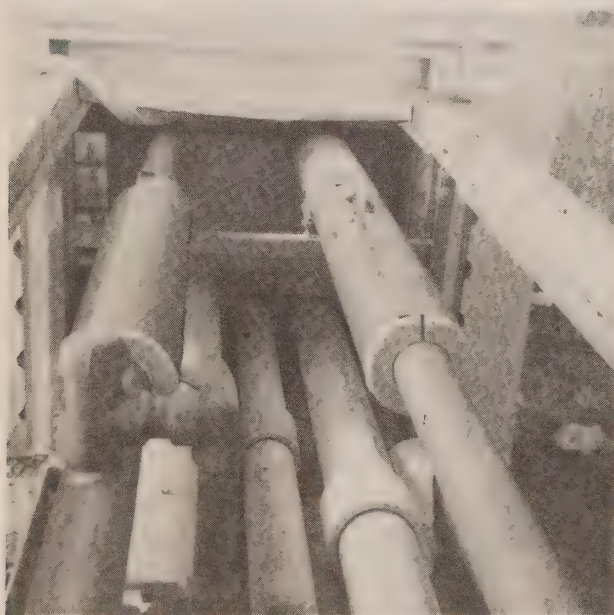
PHOTO IN-3—Exposed piping in the water supply section of the original utilidor.

The top pipes are in the 6-inch steel hot water heating supply and return lines.

Bottom right is an 8-inch A.C. sewer.

Note the aluminum sandwich side panels and the concrete thrust block.

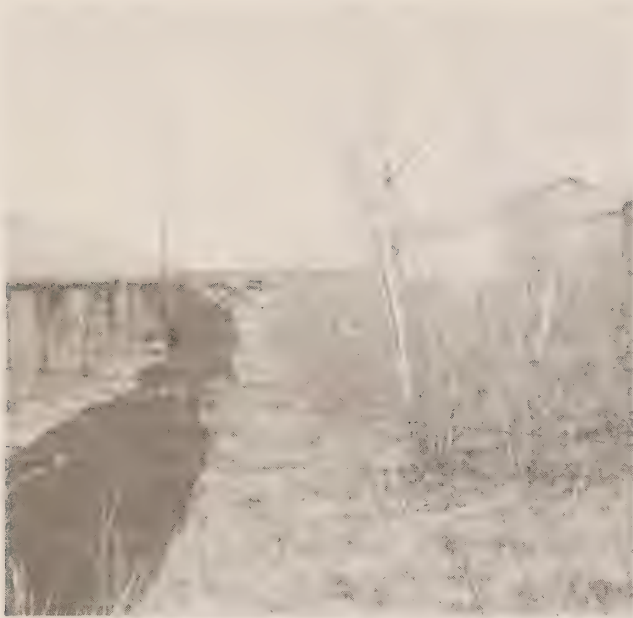
PHOTO IN-5—Lateral displacement of the utilidor located on a side-slope. Attempts to stabilize the line using cables proved ineffective. Fill placed around the piles has reduced the movement considerably.

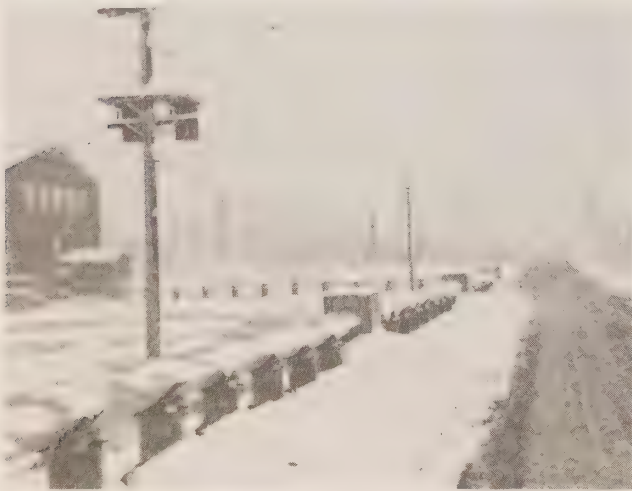
PHOTO IN-9—The modified econo utilidor supported on oil drums.

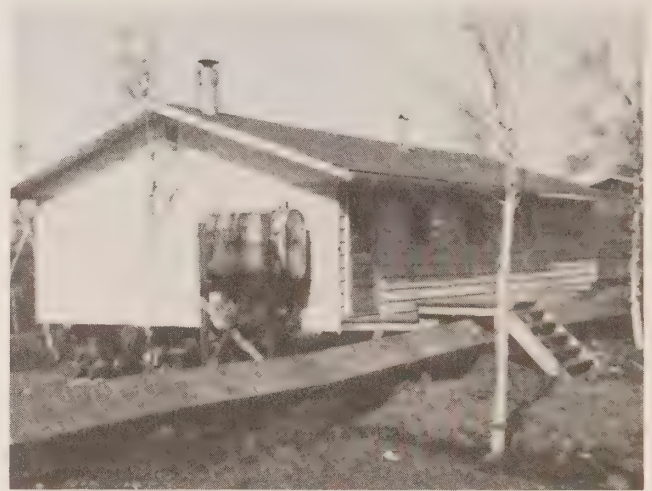
PHOTO IN-10—The modified econo utilidor on a gravel pad.

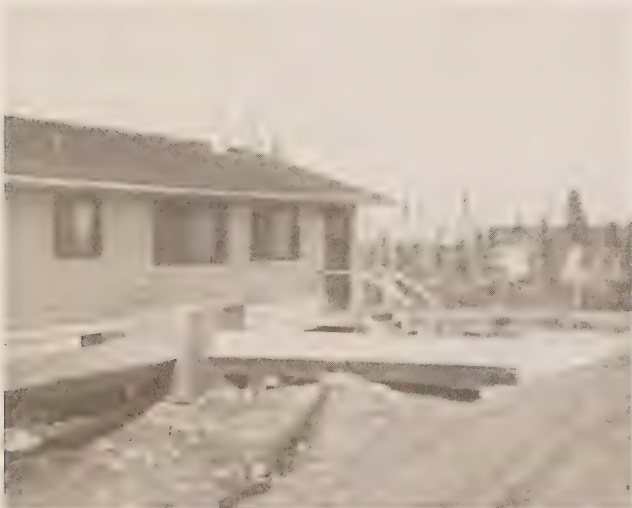
PHOTO IN-11—The modified econo utilidor encased in a culvert pipe to form a road crossing.

Note junction box.

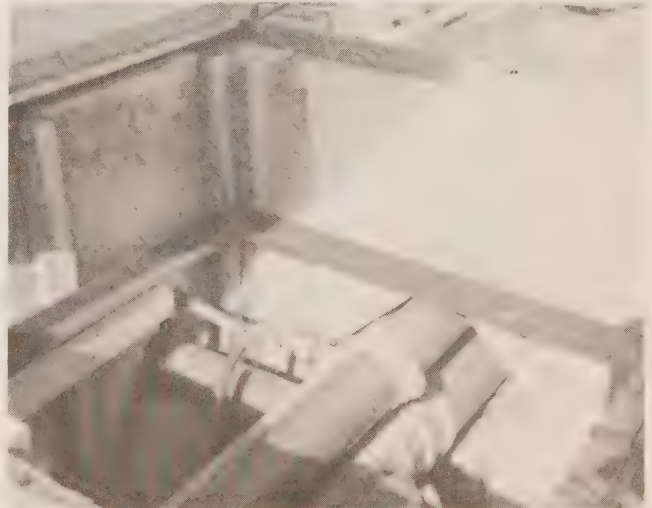
PHOTO IN-12—Exposed piping in a junction box on the modified econo utilidor line.

Upper pipe is 4 inch PVC water main with a service connection to the house.

Lower pipe is 6 inch PVC sewer line with a service connection and clean out.

To the left is the partially hidden 2 inch aluminum heat tracer line.

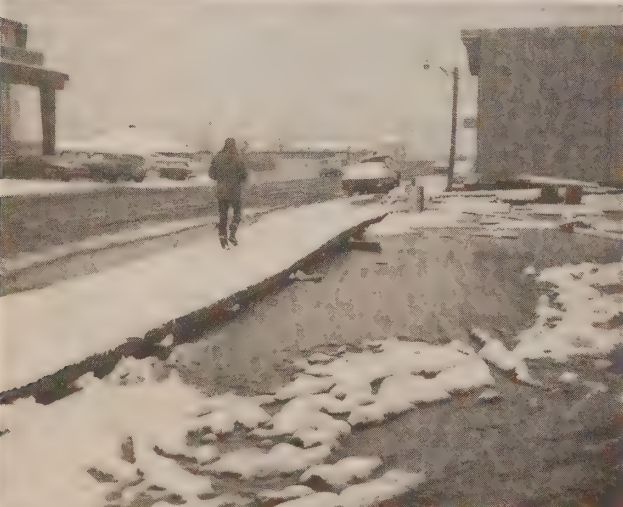
PHOTO IN-15—Poor surface drainage on MacKenzie Road in front of bank.

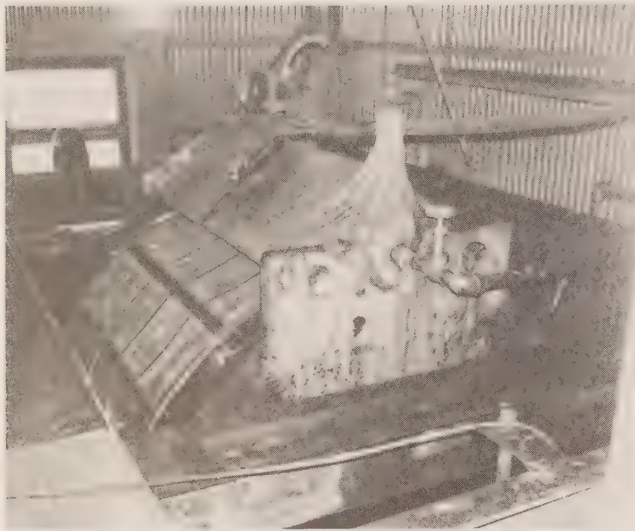
"Water is pumped from Hidden Lake and is treated by microstraining, chlorination and fluoridation, and is then put into a 90,000 gallon storage tank." (see Photo IN-17).

PHOTO IN-17—Micro strainer unit at water treatment plant.

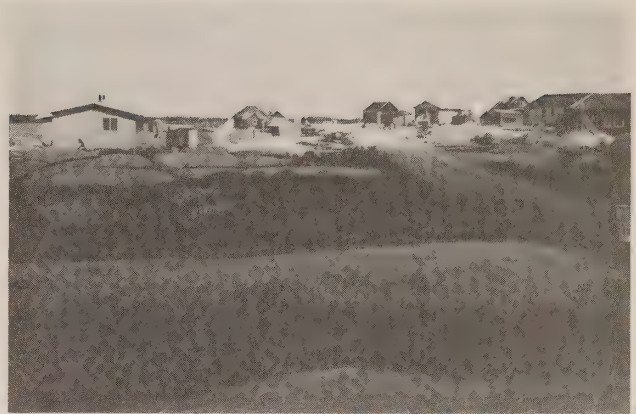
The site of the settlement, although picturesque, is very rocky (photo R-1) and the settlement is spread out over two islands and the adjoining mainland. The growth of the settlement in recent years has produced very unsanitary conditions which cannot be corrected at a reasonable cost ; therefore, in 1965, studies were undertaken to find a more suitable site. A new location was chosen with the approval of the band council. Named Edzo, it is situated on the Yellowknife highway, about 11 miles from Rae by road, or 4 miles across Marian Lake.

PHOTO R-1 – General view of Rae.

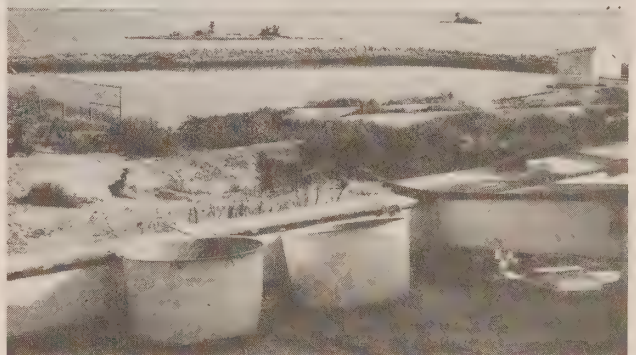
Marian Lake is less than five feet deep, turbid, highly coloured and, near the settlement, polluted from surface run-off and sewage. Until April 1971 it was the source of water for the town. A water treatment plant was built in 1965, consisting of a water reservoir built in the lake by constructing dykes 200 feet square (photo R-2).

PHOTO R-2 – Water reservoir and utilidor.

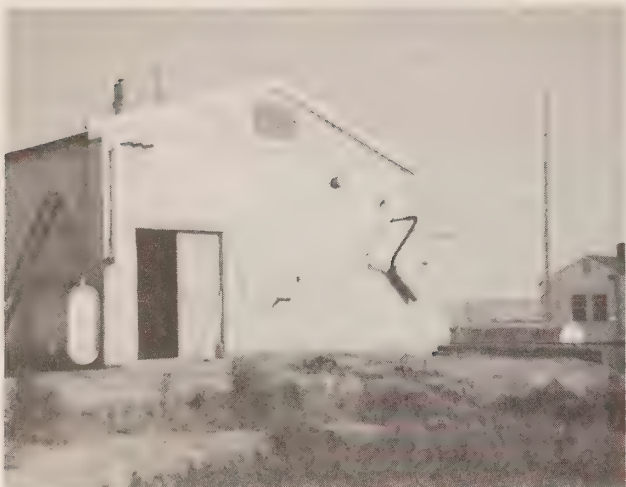
PHOTO R-3—Water treatment plant.

was pumped from the storage tank through the utilidor system serving the hospital, two RCMP constables' houses, and four trailers; water was trucked to all others homes. Evidence that the water supply system has never operated properly is provided in many reports by J. W. Grainge. It was stated that no one was instructed in the proper operation of the plant or the testing equipment, except the chlorination procedure. The plant's only service was to chlorinate the water; however, chlorination of polluted, turbid water is unsatisfactory. Evidence of poor bacteriological tests is given by Grainge (1970 o). Many Indian families also use water taken directly from Marian Lake, close to the shore, and these combined polluted water sources have resulted in numerous cases of disease that was probably waterborne. Grainge (1970 o) reported in detail an outbreak of gastroenteritis in Rae in the spring of 1970. There were 20 severe cases among children under two years of age, of whom three died. In the spring of 1971 another outbreak of disease occurred, resulting in an order from the medical officer of health to discontinue using the water treatment plant. Since 10 April 1971, all water for Rae has been trucked from the new well at Edzo, 11 miles from Rae. It is chlorinated by HTH dose in the supply truck. Residents complain about hard water, since they were used to soft lake water previously, and the chlorine taste. In spite of the frequent outbreaks of disease, it seems impossible to prevent the use of Marian Lake water by many of the native families. The water treatment plant is now used only for storage.

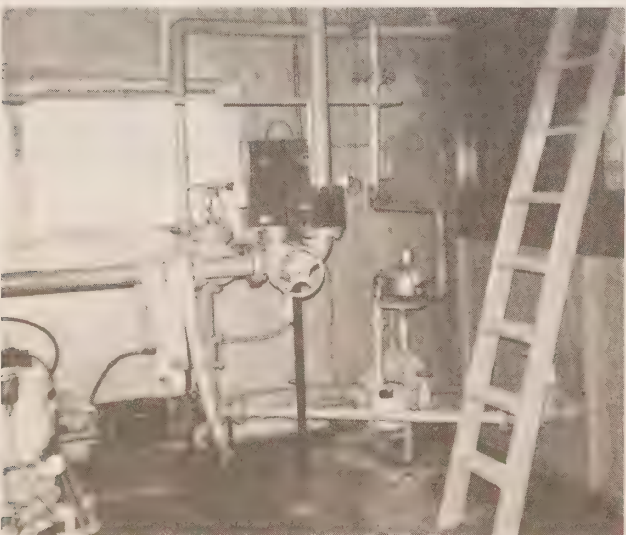
PHOTO R-5—Inside water treatment plant. Storage tank on right.

The tank at the water treatment plant provides storage for about 4200 gallons. The inside of the tank shows many rust spots and has not been recently painted. A level control is connected to what appears to be a low-level alarm. It could not be established whether it was in working order, but it seems doubtful since it was reported that the storage tank has run dry on several occasions. Water points have been constructed at six locations in the settlement, 1000-gallon fibre glass tank and five 500-gallon tanks. These are filled during the regular water delivery to provide additional water for residents whose tanks have run dry.

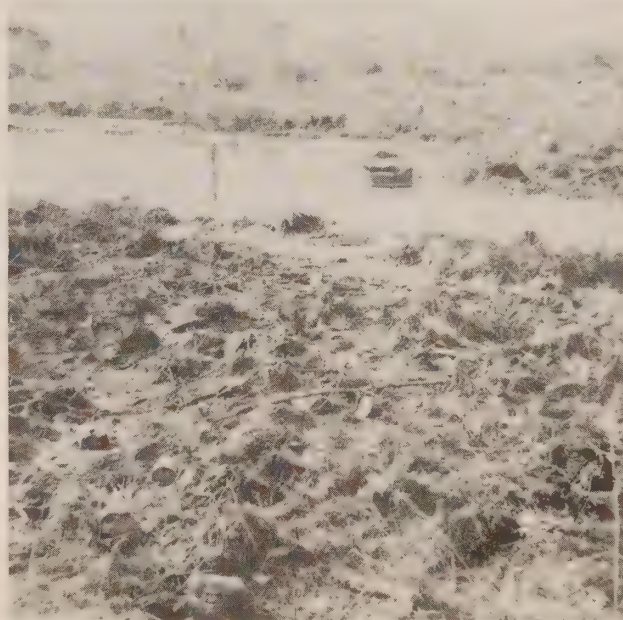
PHOTO R-6—Receiving "stream" at rear of sewage treatment plant.

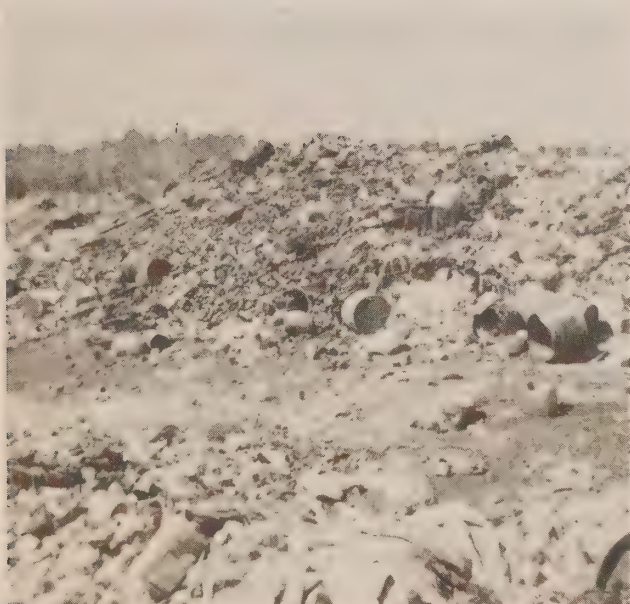
PHOTO R-10—Garbage disposal site.

- The garbage site should be covered with gravel more frequently than is apparently done now.
- Disposal of honey bags at the lagoon site was apparently not intended, and will soon cause a problem since it is not possible to push it further or to cover it. It may be better to dispose of honey bags at the garbage dump, where they can be covered regularly.

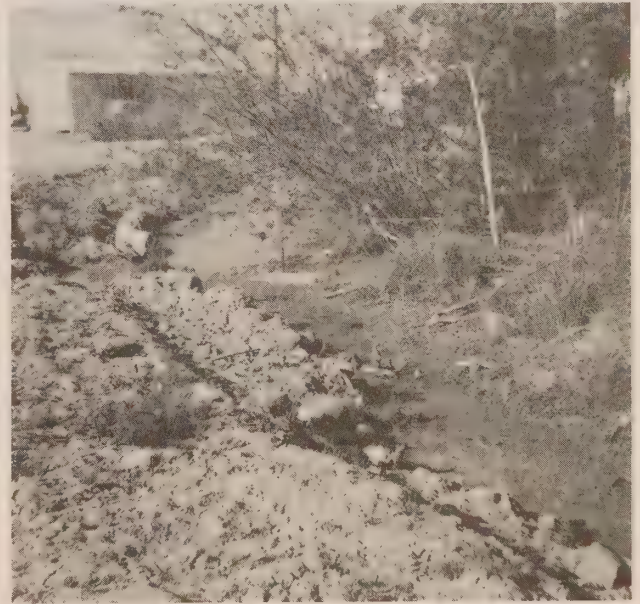
PHOTO R-11—Poor drainage ditch near playground.

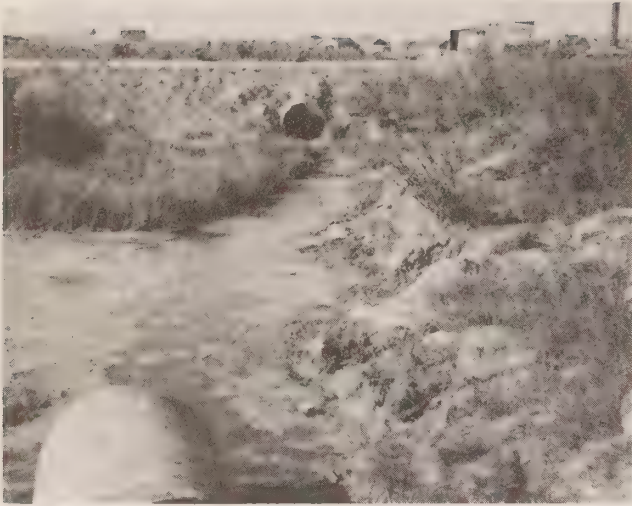
PHOTO R-12—Poor drainage, culvert at rear set too high.

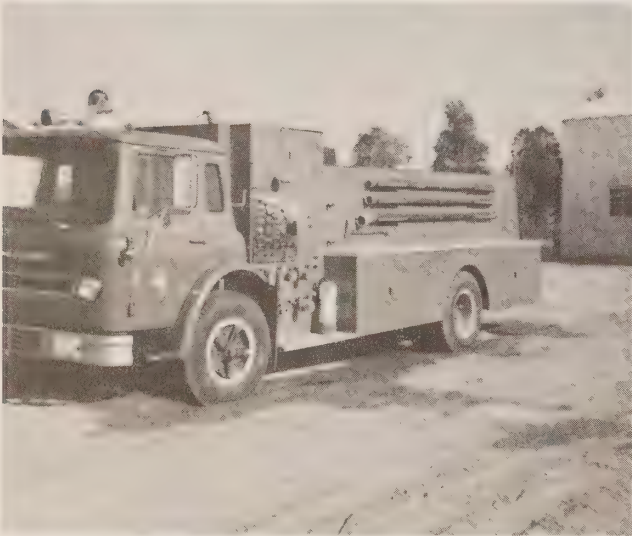
PHOTO R-13—Fire truck.

The town recently purchased a fire truck (photo R-13) with a 1200-gallon tank. It is kept full at all times and

parked at RIX Trucking garage (photo R-14), at a cost of \$110 a month. In addition, two water trucks are kept full at night. In case of a serious fire, additional water is obtained from the lake. There is a volunteer fire brigade.

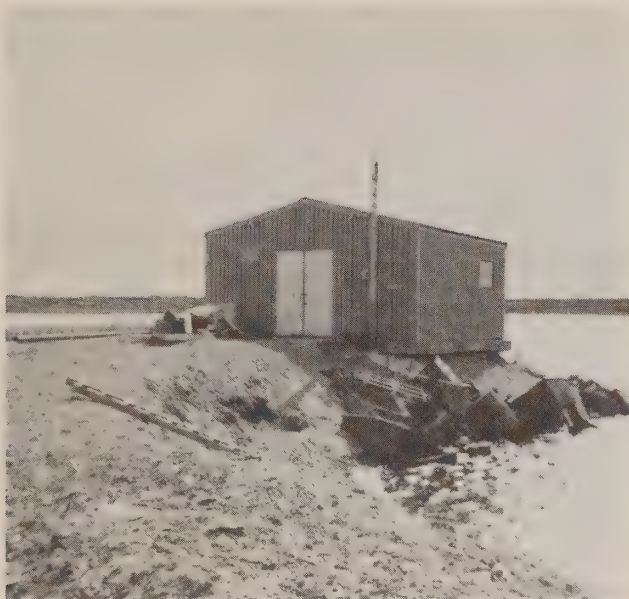
PHOTO RI-1 – Pumphouse at Williamson Lake.

The intake on Williamson Lake is approximately 65 feet from shore, and is housed in a 20 foot by 20 foot pumphouse at the end of the causeway (Photo's RI-1, RI-2). Water is drawn through a hot-water heated extension which projects horizontally from the pumphouse wall, then vertically into the lake. Pumping is performed by one of the 10 h.p. and 25 h.p. electric motors. There is a diesel motor on standby, and in winter, 50 h.p. electric motor is used to fill the reservoir.

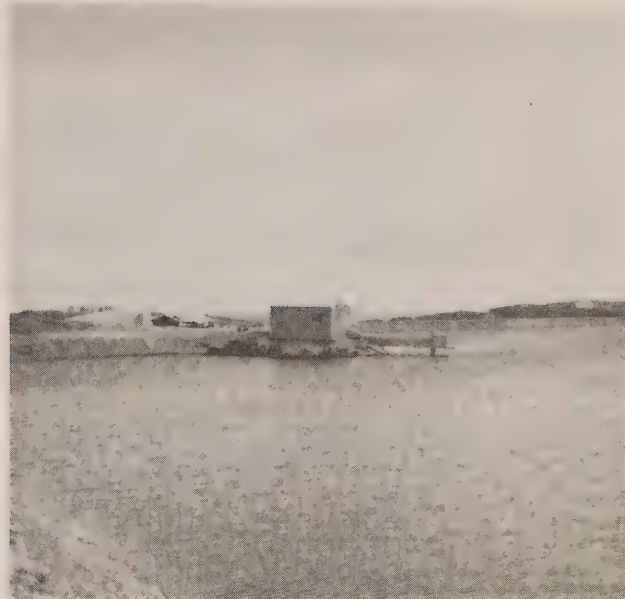
PHOTO RI-2 – Pumphouse and intake projection.

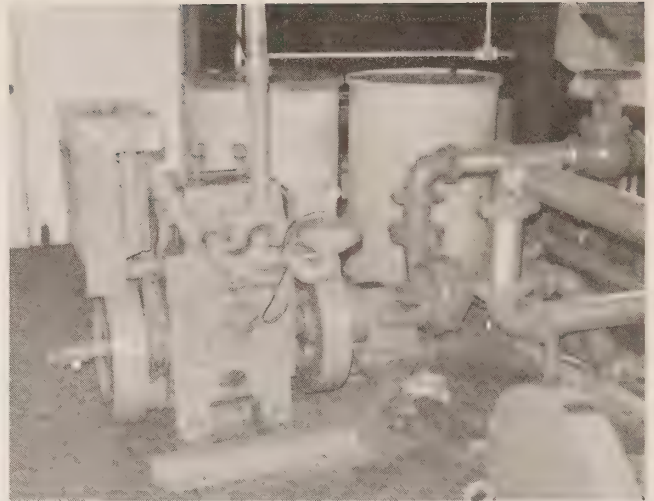
The treatment unit has facilities for fluoridation, and the necessary local plebiscite had approved the addition of fluoride. No action has yet been taken since it is feared that the recirculating supply system, with excess water being returned to the reservoir, would ultimately cause a buildup of fluoride in the reservoir. There have been no complaints from white house-holders concerning water quality. Some Eskimos, however, haul their own ice and water from Williamson Lake, with no apparent ill effects. It is interesting to note that, even with the chlorinator inoperative, some residents were still objecting to the taste of water delivered.

PHOTO RI-3—Water treatment equipment with facilities for chlorination and fluoridation.

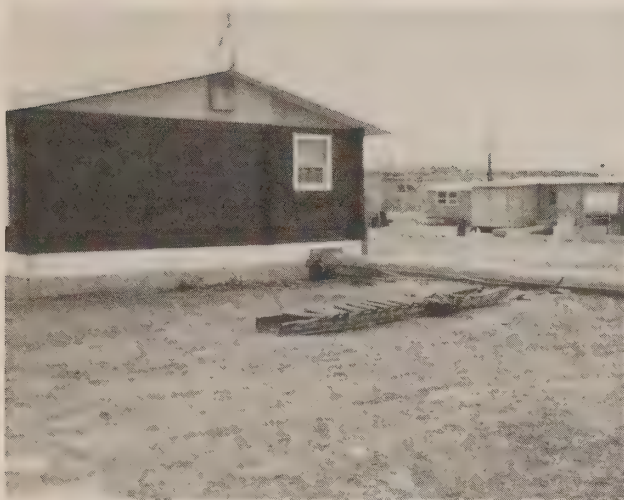
Connections to the utilidor are made where the utilidor passes through the crawl space beneath a building (photo RI-6), or by an insulated, square-box utilidor (photo RI-7). Shifting of buildings and settling of the utilidor beneath some of the houses have caused some minor misalignment at some of the house connections.

PHOTO RI-6—House connection via crawl space.

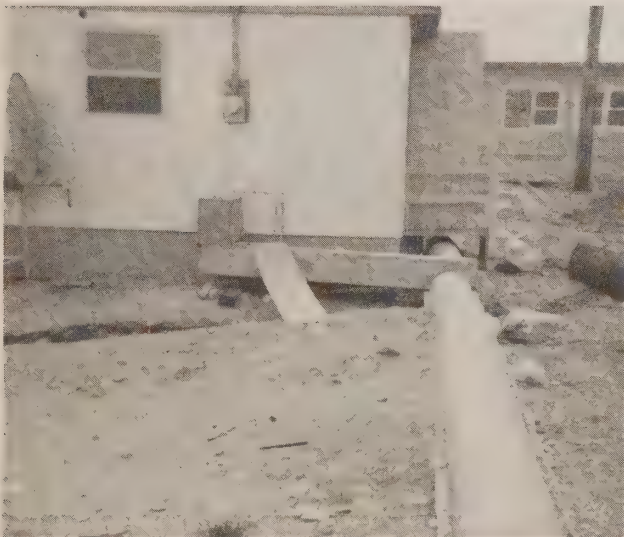
PHOTO RI-7—Wood-box utilidor connection to house.

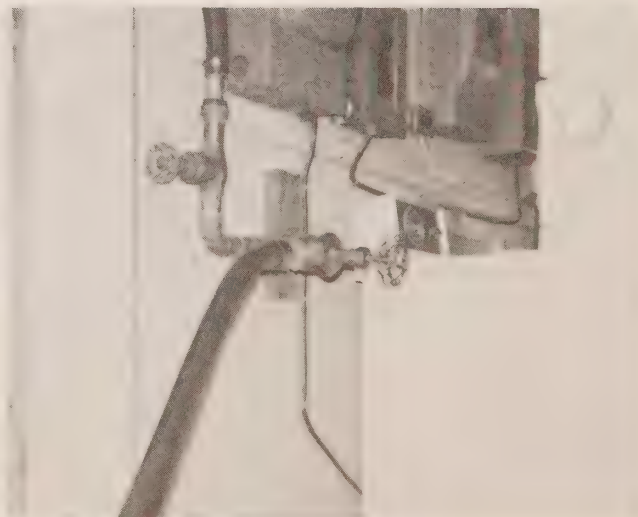
The Muskeg MS9 (Photo RI-10) tracked water vehicle is filled at the bath-house using a three-inch-diameter rubber hose (photo RI-11). The nozzle, which on several occasions was observed on the ground beside the building, fills the 500-gallon tank in 10 to 15 minutes.

PHOTO RI-11 – Filling water vehicle at the bath-house.

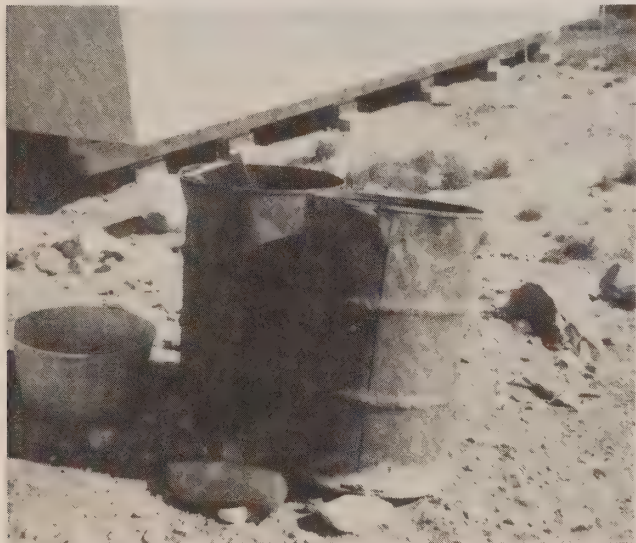
PHOTO RI-12 – Honey bags lying beside garbage cans.

45-gallon drums provided for the dry garbage of each household. (Photo RI-12). On the ground the transparent poly-bags are often broken by dogs and children with sticks and stones. In winter they freeze to the ground and are covered by snow.

It was reported that the council is considering building stands for garbage pails. Each stand would serve two houses and hold four standard 20-gallon garbage cans; two each for wet and dry garbage. The result would be fewer collection points, reduced interference by children and dogs, and conditions would be less unsightly.

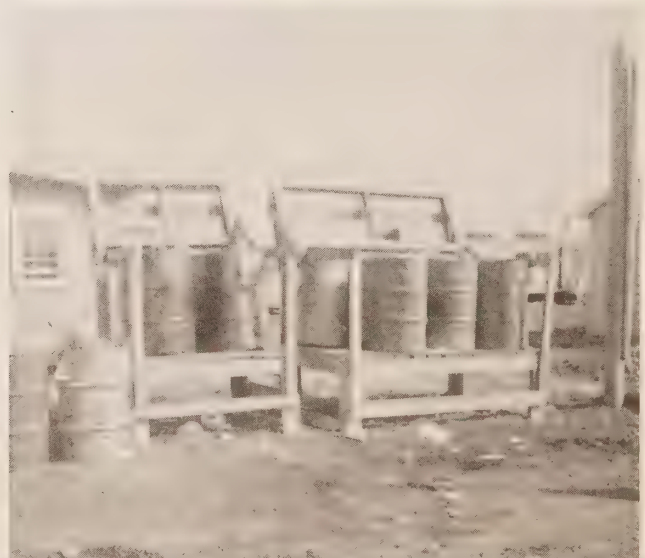
PHOTO T-6—Garbage barrels.

on racks to prevent blowing of loose papers (photo T-6). Garbage is hauled to the dump by a private contractor twice a week. As much as possible the combustible refuse is separated and burned from time to time. The contract cost of this is 60¢ per barrel per pickup, for a total annual price of \$6,240. Of this, \$200 is budgeted for barrel maintenance. There is no charge to users, but many people find it easier to dispose of garbage along the beach, on the ice of the bay, or into Pokiak Lake (photo T-7).

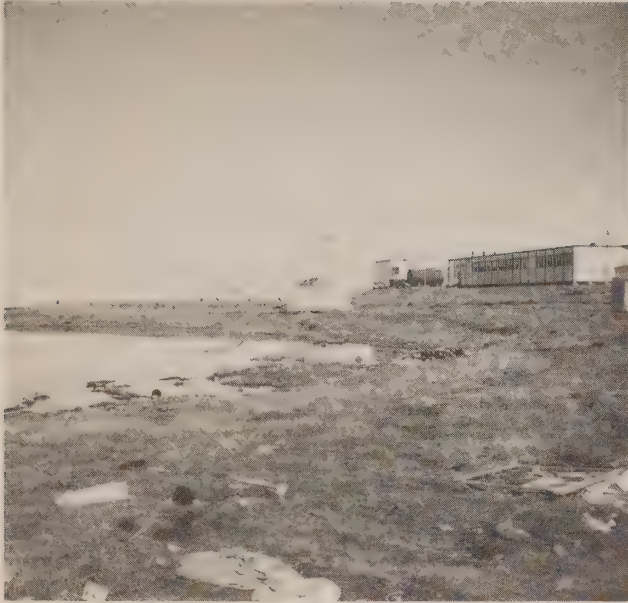
PHOTO T-7—Poliak Lake near the school.

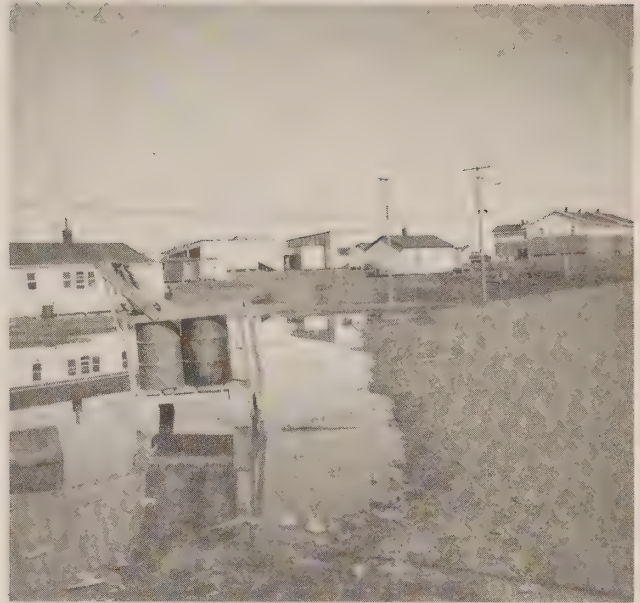
Surface drainage is generally poor. Ponding problems caused by the lack of culverts and ditches along the roads could be easily solved (photo T-8). Surface drainage should be considered when future roads are being planned as well as the provision of adequate culverts. The melting of permafrost for unknown reasons has led to the formation of at least one deep pond in the settlement. This is used for the disposal of garbage and honey bags. Attempts to fill it have been unsuccessful so far.

PHOTO T-8—Lack of culverts causing ponding.
